Technical Information

Cascaded appliances with OEtroCom-3 control panel:

Compatibility of PCBs - Troubleshooting

JS	N° **ITOE0237A-en**	06/10/2020

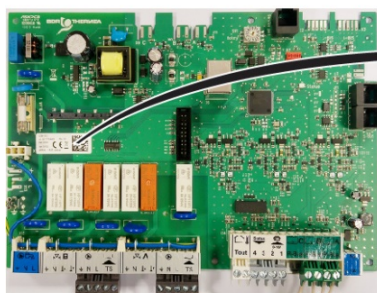
If one of the following error codes appear: **A02.49**, **H02.47**, **H02.48** or **H02.49**
and there is no dysfunction:

3. Select **Version Information** ⓘ,
4. Sélect : **SCB-10** PCB,
5. Check the line : **Software version**… : **1.2** = SCB-10_C ;   **1.3** = SCB-10_D ;   **1.4** = SCB-10_E.

- Check the **SCB-10** version on each of the devices in the cascade.
- Replace the previous versions of the **SCB-10** PCB with version **E** (= SW 1.04).
- Carry out a PCB **autodetection** to update the system.

Replace all previous versions of **SCB-10** PCB by version **SCB-10-E**, available in spare parts, under the reference:
7764825 Electronic PCB SCB-10_E (SW 1.04).
